**Board of Equalization Building**  
450 N Street, Sacramento, CA 95814  
**Corroded Drain Line Investigation**  
**Prepared for DGS**

Interactive Resources Project No. 2011-099-01  
IDGS Contract No. 3158936 (BPM #028)

November 25, 2013

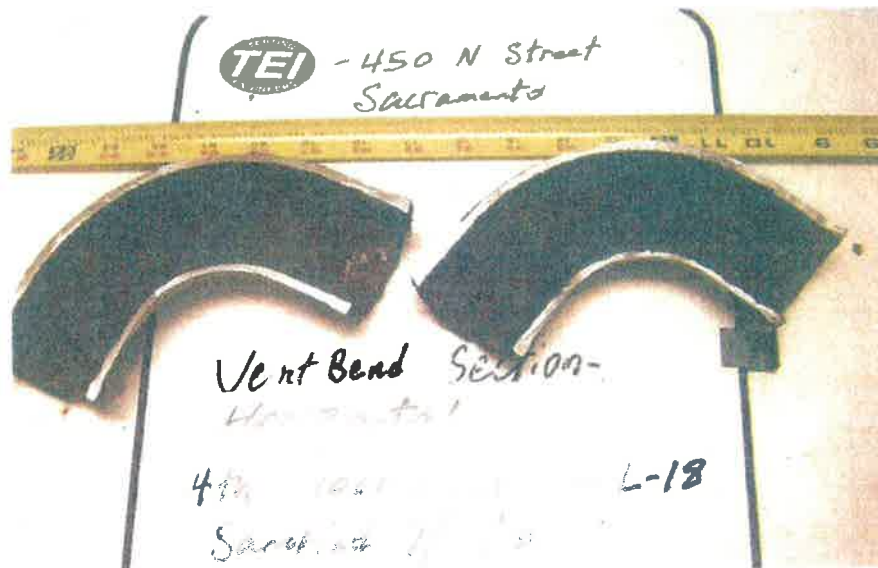
Photo 2 - Sample 1 - Interior

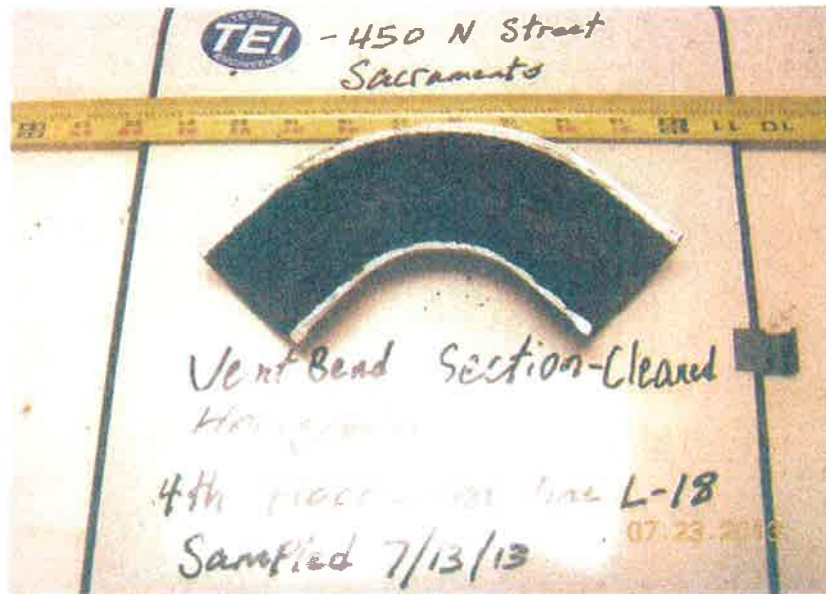
Photo 3 - Sample 1 - Cleaned

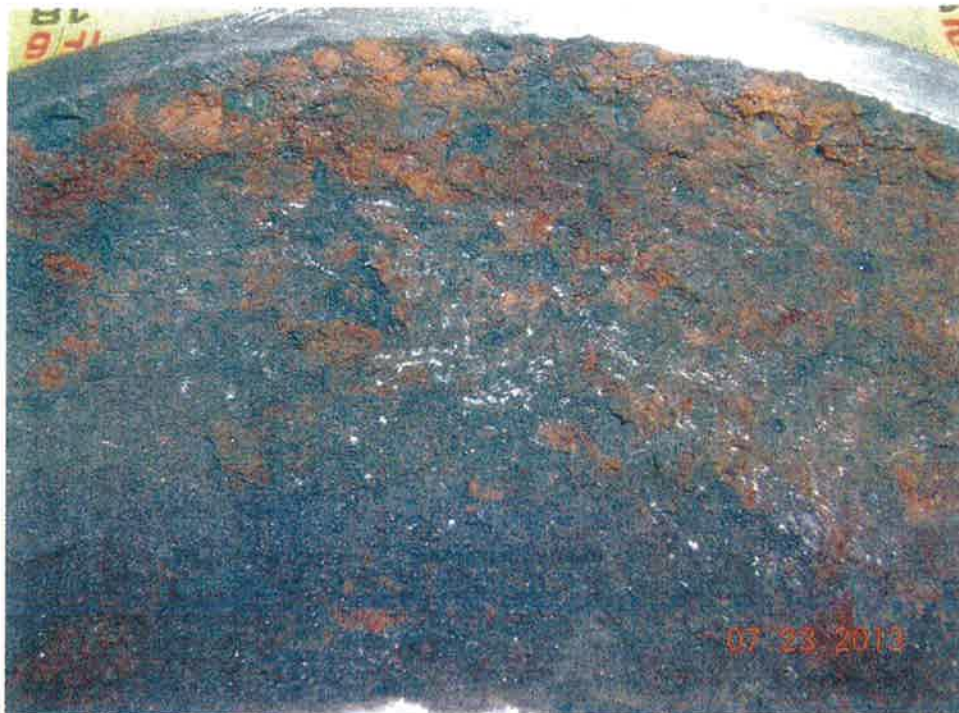
Photo 4 - Sample 1 - Cleaned - Close-Up

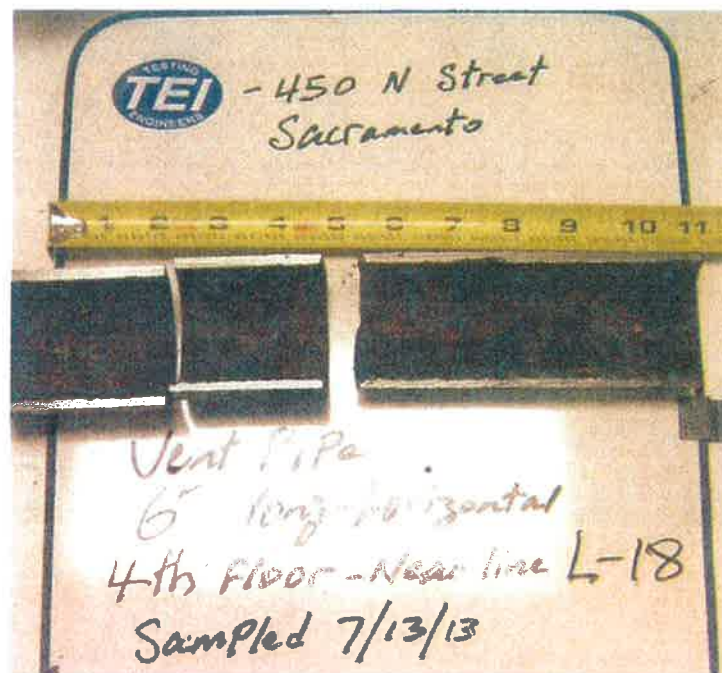
Photo 6 - Sample 2 - Interior

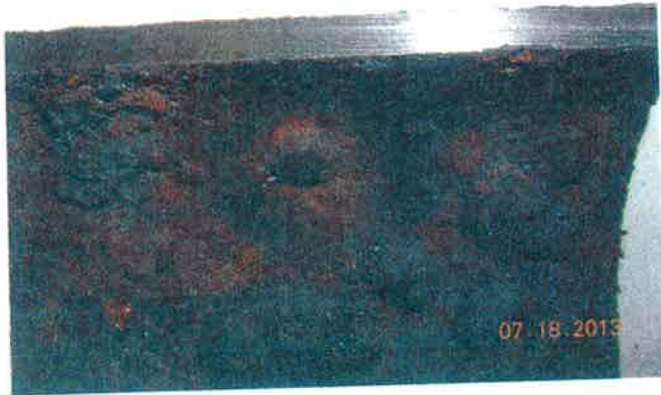
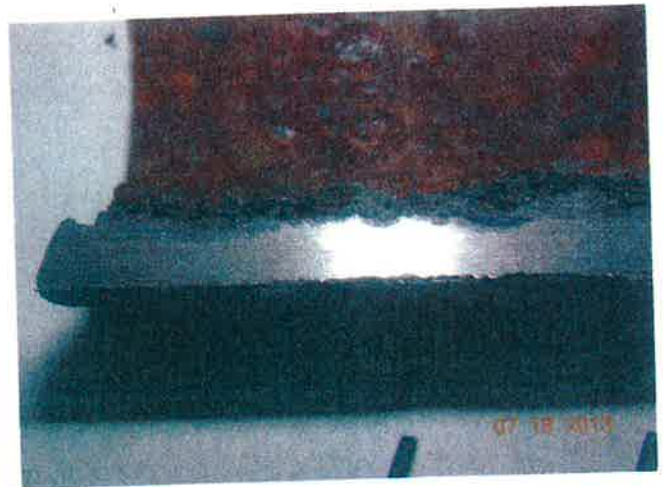
Photos 7a and 7b – Sample 2 – Cross Section and Interior Views

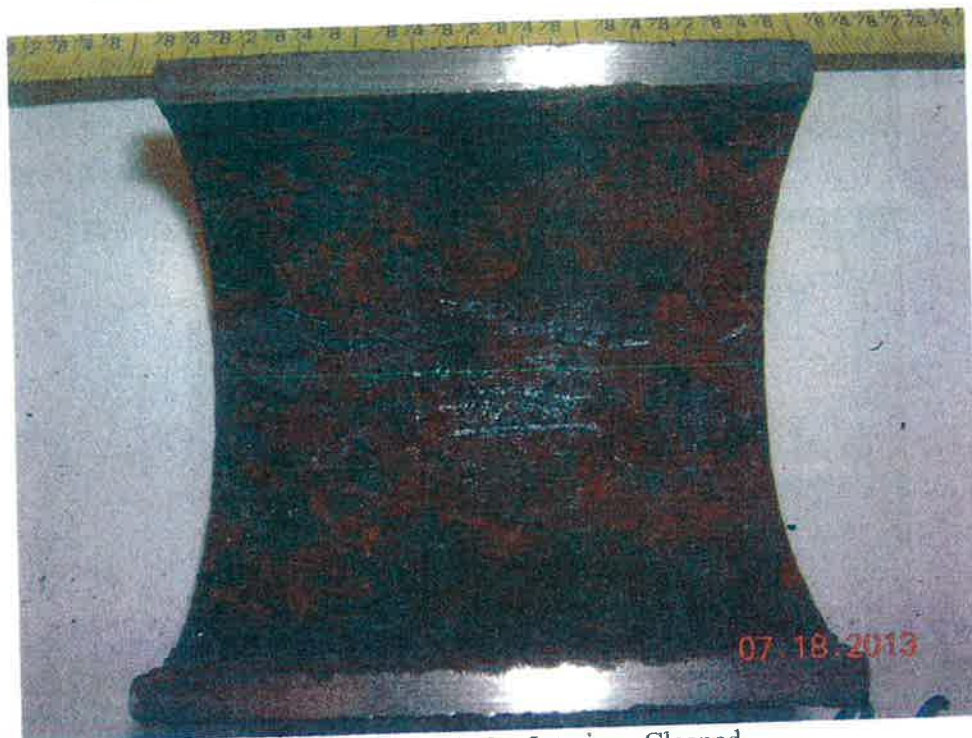
Photo 8 – Sample 2 – Interior - Cleaned

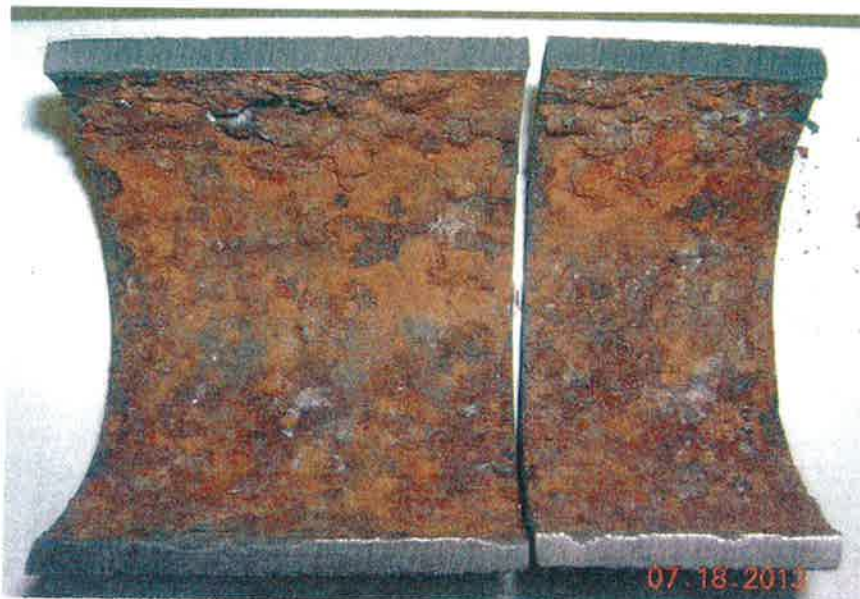
Photo 10 - Sample 3 - Interior

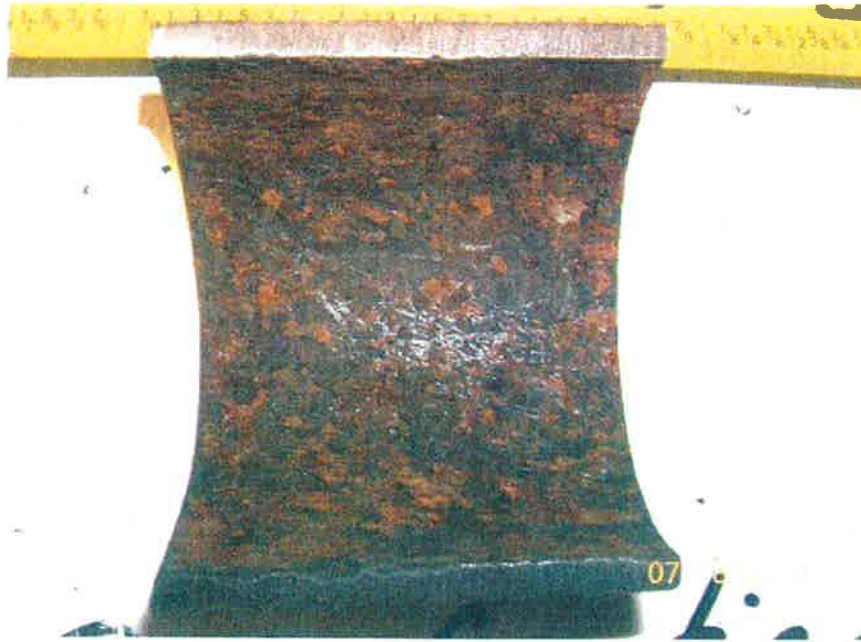
Photo 11 – Sample 3 - Interior - Cleaned

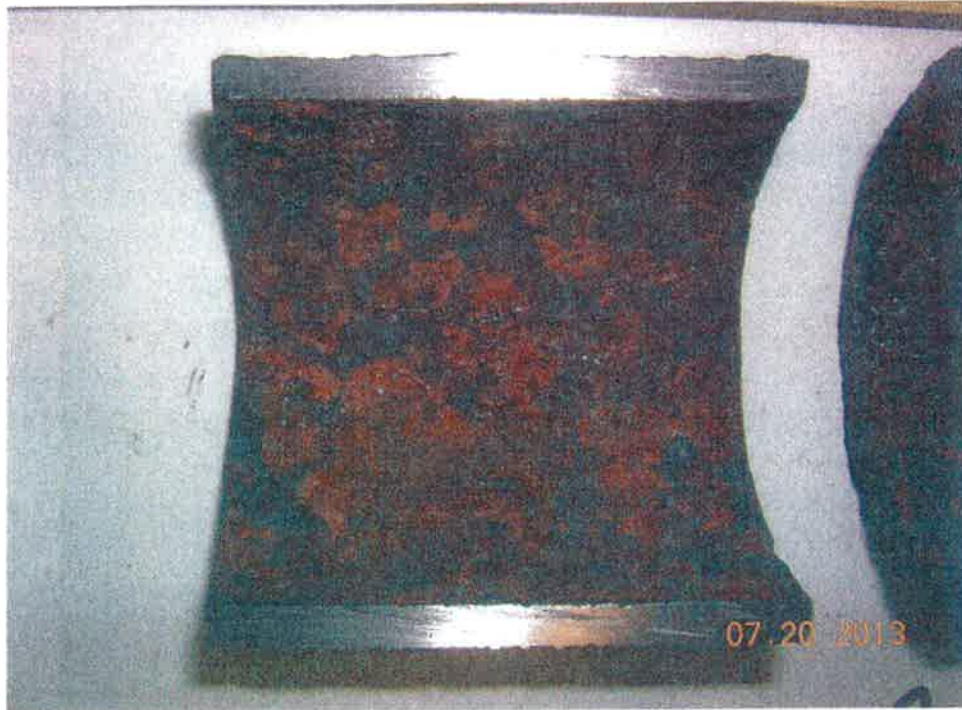
Photo 13 -- Sample 4 -- Interior

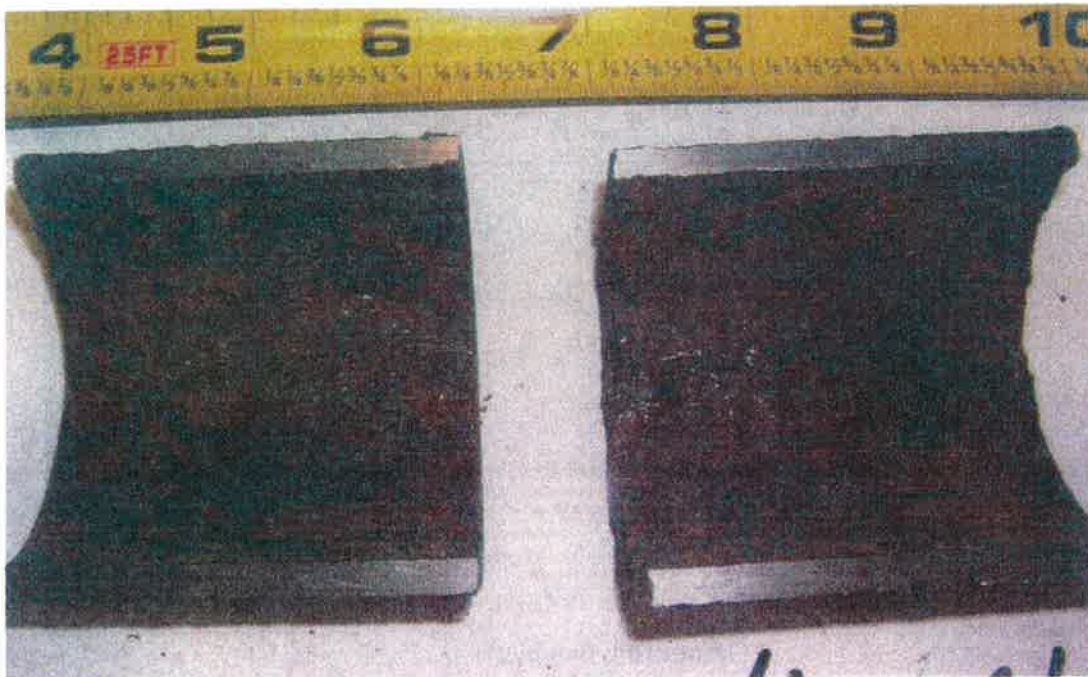
Photo 14 - Sample 4 - Interior - Cleaned

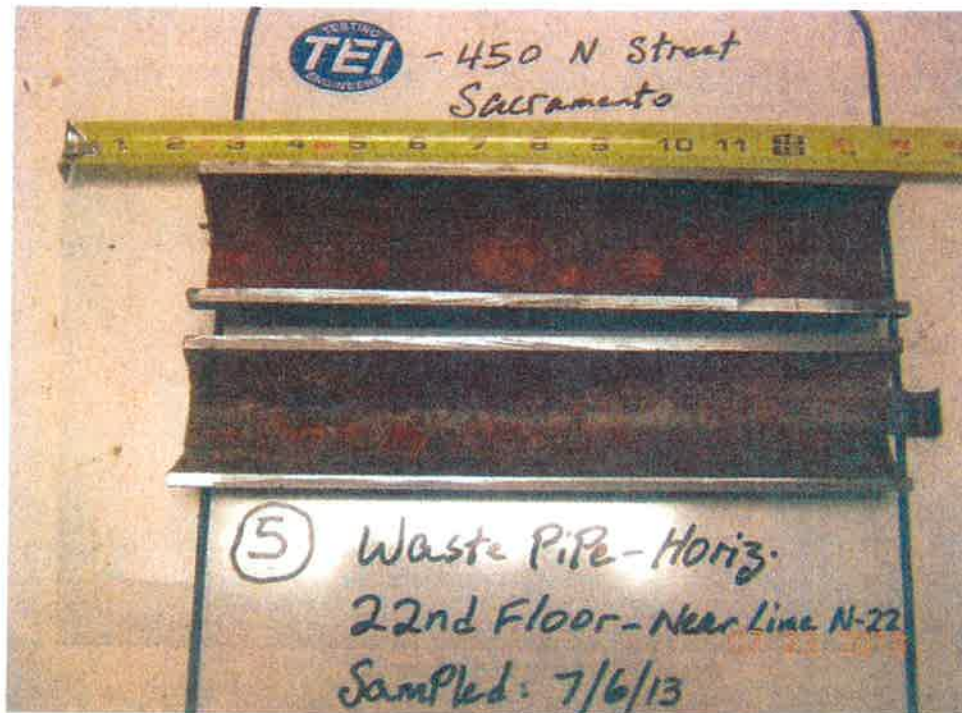
Photo 17 - Sample 5 - Interior

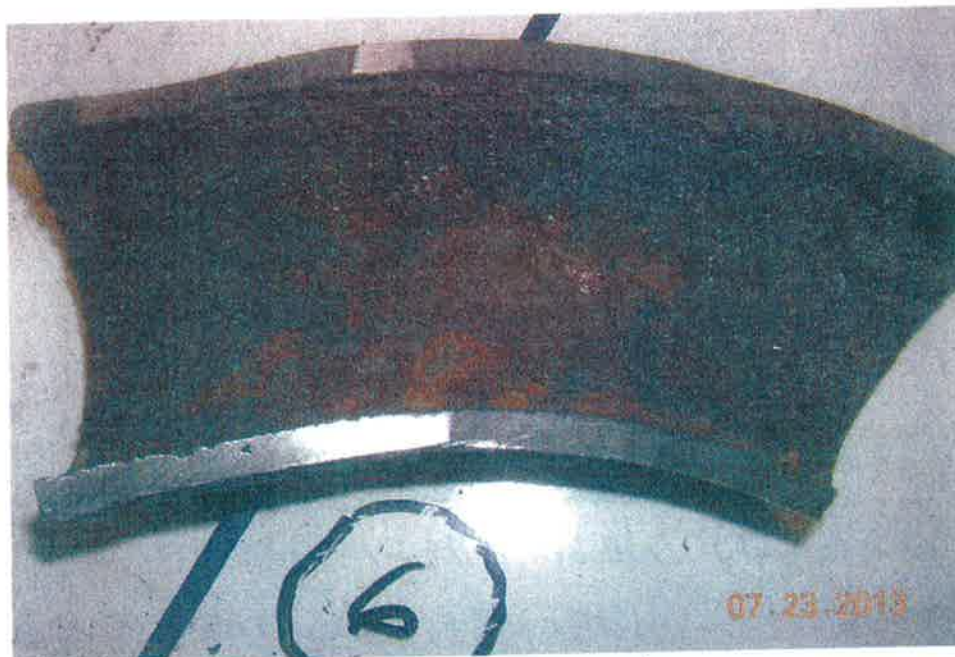
Photo 19 – Sample 6 - Interior

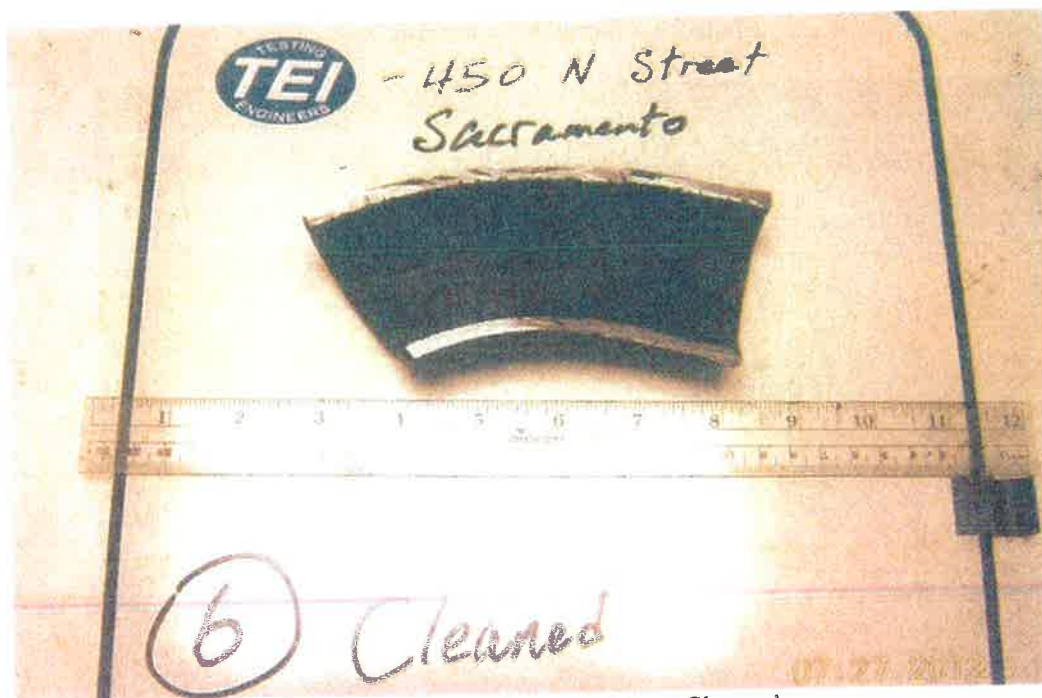
Photo 20 – Sample 6 – Interior - Cleaned

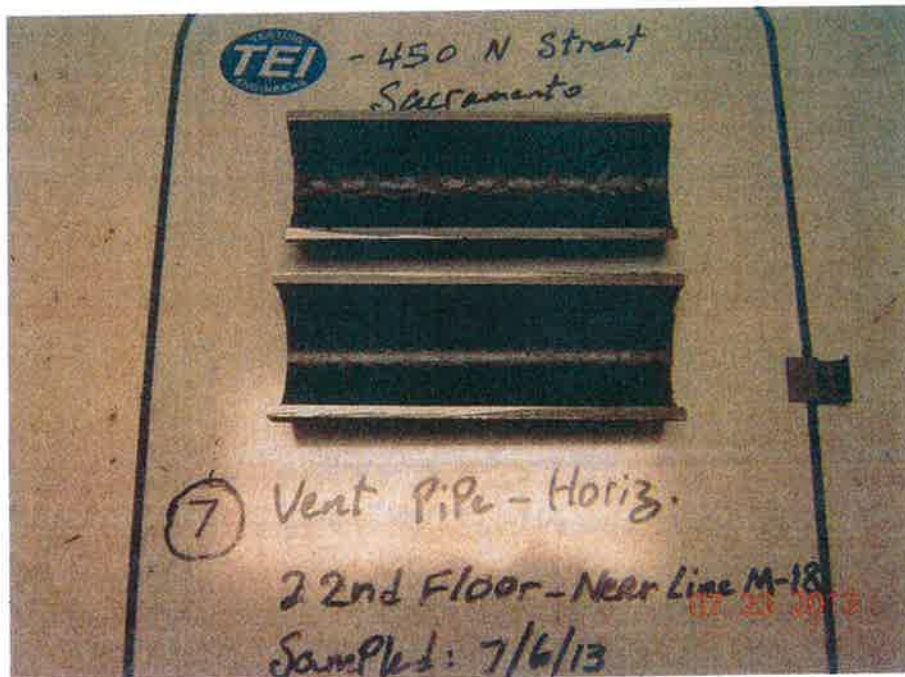
Photo 22 - Sample 7 - Interior

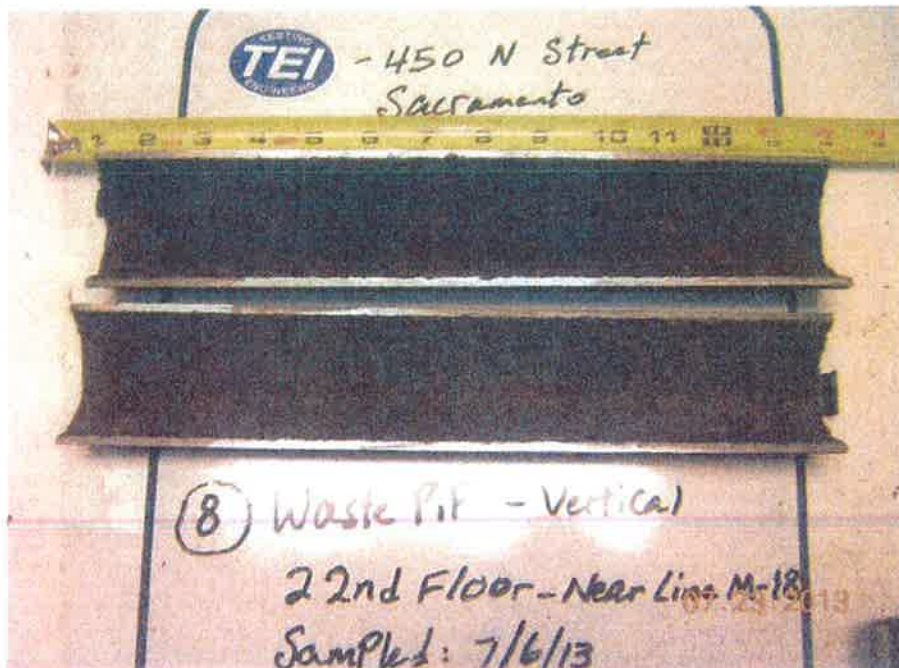
Photo 24 - Sample 8 - Interior

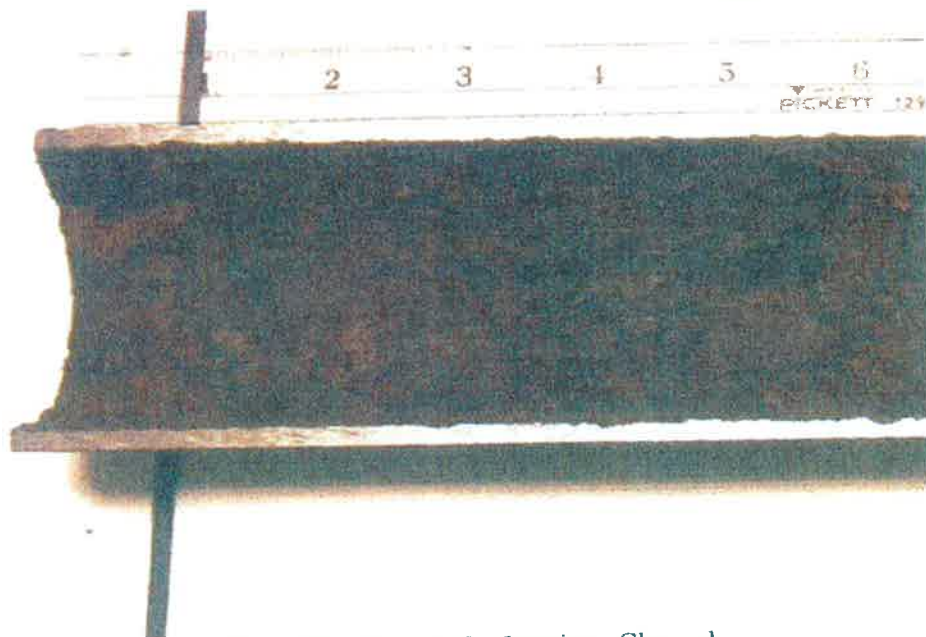
Photo 25 - Sample 8 - Interior - Cleaned

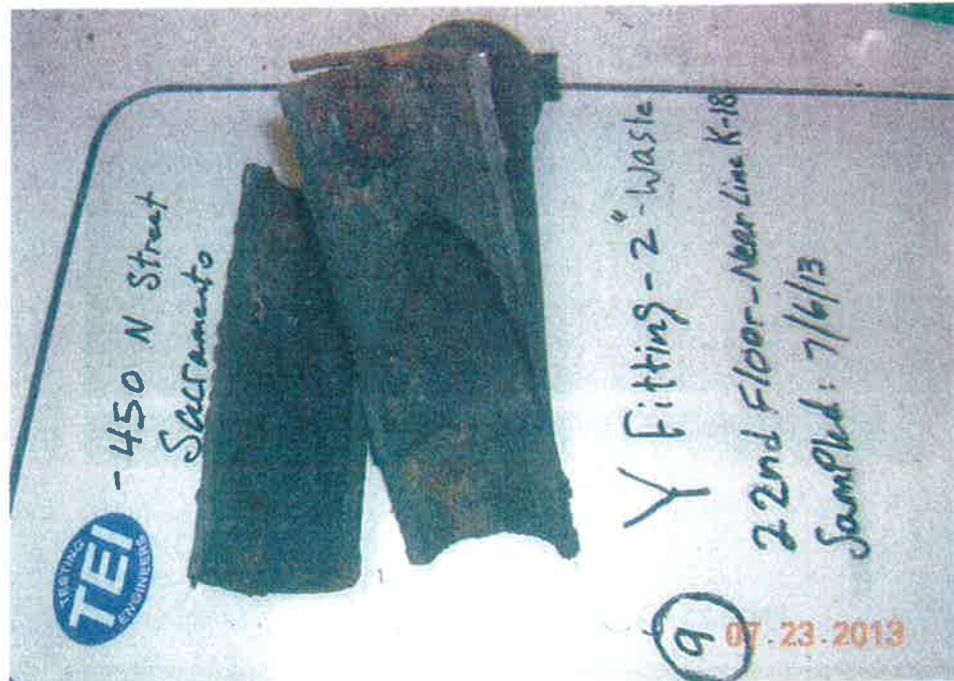
Photo 27 - Sample 9 - Interior

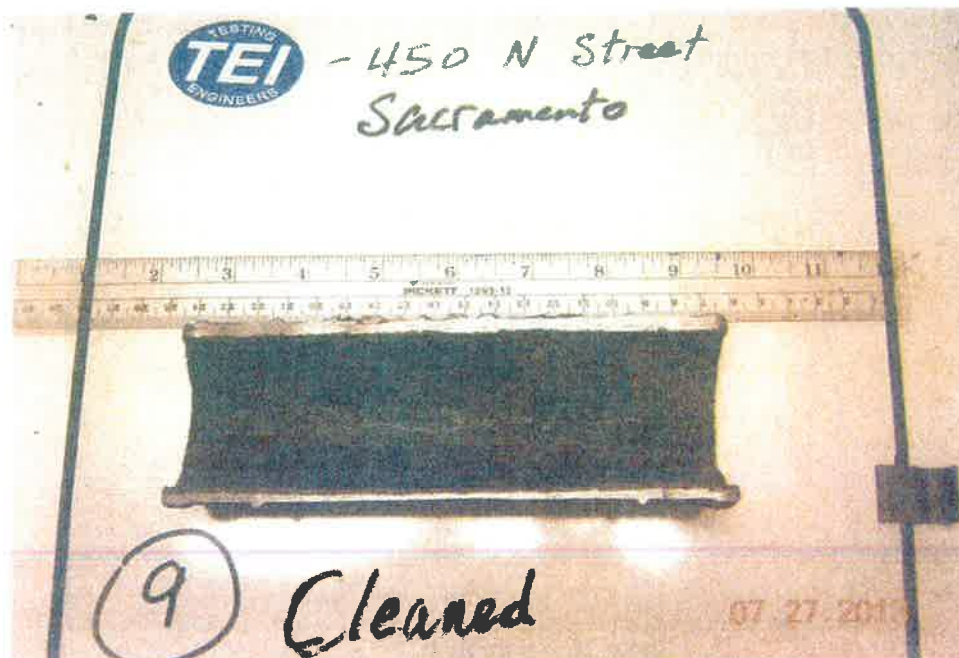
Photo 28 - Sample 9 - Interior - Cleaned

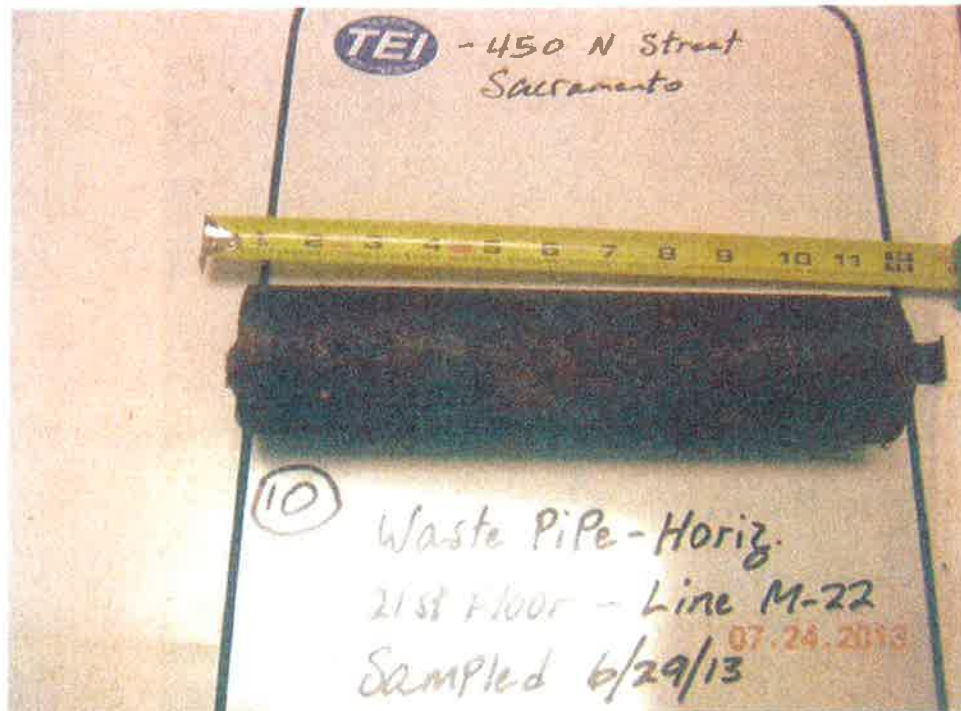
Photo 29 - Sample 10

| TEI Sample No. | Sample Type | Location | Date Sampled | Observations | Laboratory Thickness Measurements, inch | Overall Views Photo No. | Macrographs Photo No. | Macrographs Photo No. |
|---|---|---|---|--|--|---|---|---|
| 10 | 12" long pipe, horiz. waste | 21 <sup>st</sup> floor M-22 | 6/29/13 | Minimal corrosion, moderate to severe build up | N/A | 29, 30, 31 | N/A | N/A |

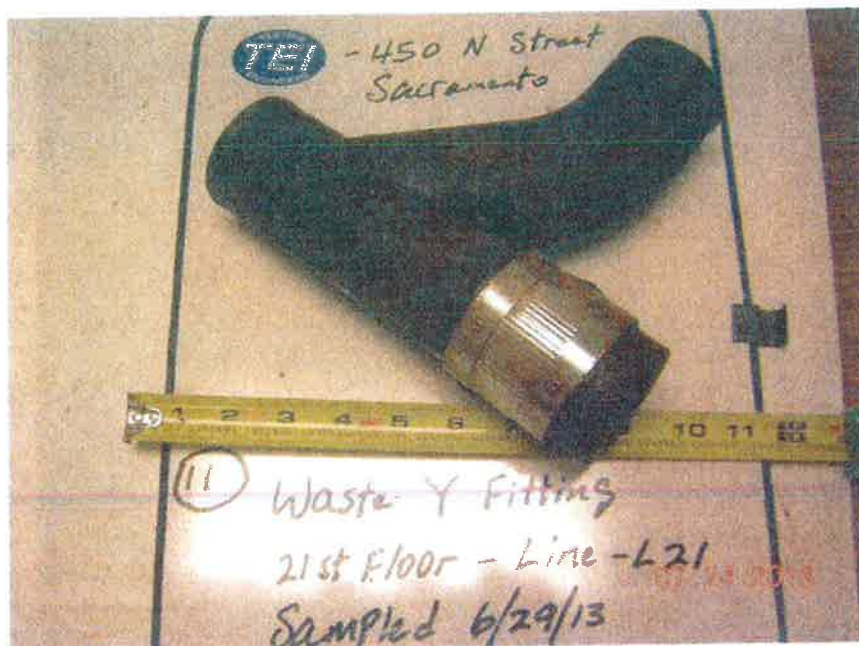
Photo 32 – Sample 11

| TEI Sample No. | Sample Type | Location | Date Sampled | Observations | Laboratory Thickness Measurements, inch | Overall Views Photo No. | Macrographs Photo No. | Macrographs Photo No. |
|---|---|---|---|--|--|---|---|---|
| 11 | Fitting, waste | 21 <sup>st</sup> floor M-21 | 6/29/13 | Minimal corrosion, severe build up | N/A | 32, 33, 34 | N/A | N/A |

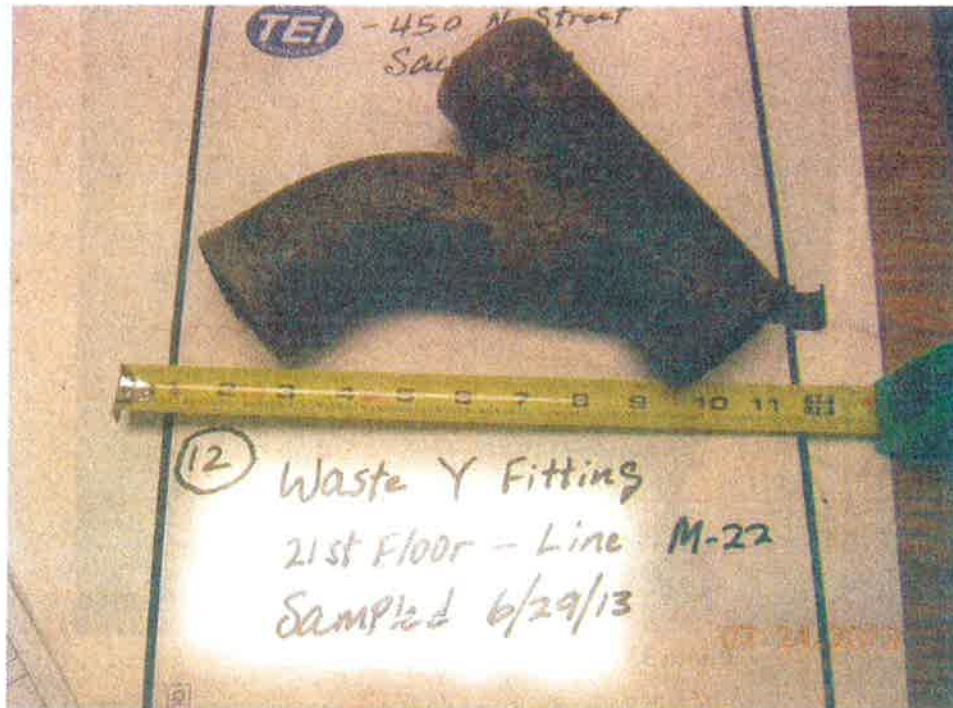
Photo 35 - Sample 12

| TEI Sample No. | Sample Type | Location | Date Sampled | Observations | Laboratory Thickness Measurements, inch | Overall Views Photo No. | Macrographs Photo No. | Macrographs Photo No. |
|---|---|---|---|--|--|---|---|---|
| 12 | Fitting, waste | 21 <sup>st</sup> floor M-22 | 6/29/13 | Minimal/moderate corrosion, | Intact - 0.187<br>Corroded - 0.109 | 35, 36, 37 | 72, 73 | 85 |

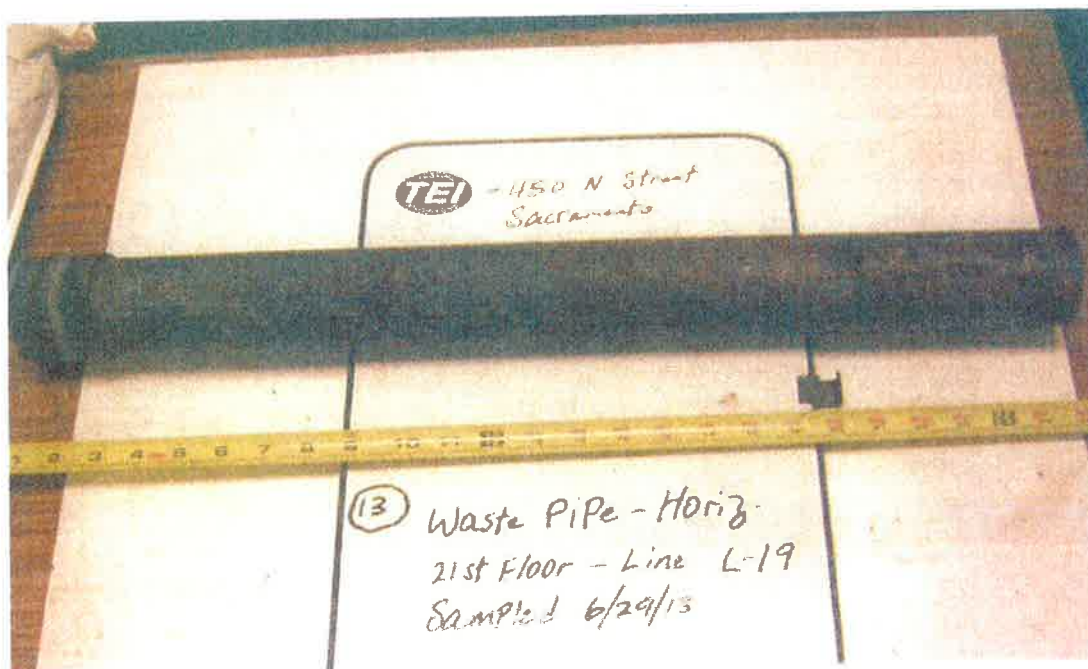
Photo 38 – Sample 13

| TEI Sample No. | Sample Type | Location | Date Sampled | Observations | Laboratory Thickness Measurements, inch | Overall Views Photo No. | Macrographs Photo No. | Macrographs Photo No. |
|---|---|---|---|--|--|---|---|---|
| 13 | 24" long pipe, horiz. waste | 21 <sup>st</sup> floor L-19 | 6/29/13 | Moderate corrosion, moderate/severe build up | N/A | 38, 39, 40 | N/A | N/A |

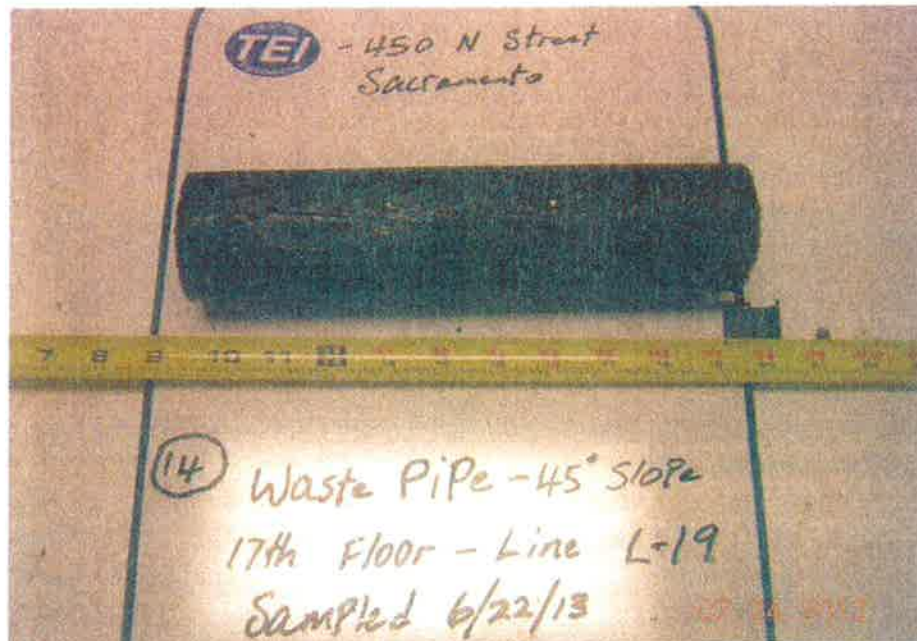
Photo 41 - Sample 14

| TEI Sample No. | Sample Type | Location | Date Sampled | Observations | Laboratory Thickness Measurements, inch | Overall Views Photo No. | Macrographs Photo No. | Macrographs Photo No. |
|---|---|---|---|--|--|---|---|---|
| 14 | 12" long pipe, 45° slope, waste | 17 <sup>th</sup> floor, L-19 | 6/22/13 | Moderate/severe corrosion and moderate build up | N/A | 41, 42, 43 | N/A | N/A |

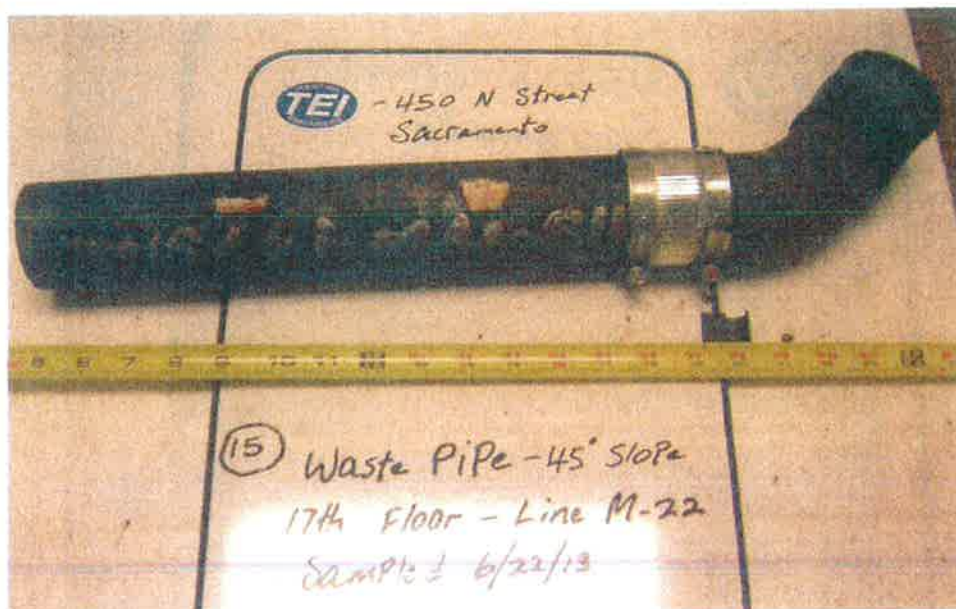
Photo 44 – Sample 15

| TEI Sample No. | Sample Type | Location | Date Sampled | Observations | Laboratory Thickness Measurements, inch | Overall Views Photo No. | Macrographs Photo No. | Macrographs Photo No. |
|---|---|---|---|--|--|---|---|---|
| 15 | 12" long pipe, 45° slope, waste | 17 <sup>th</sup> floor, M-22 | 6/22/13 | Moderate Corrosion/Severe Build Up | Intact - 0.156<br>Corroded - 0.078 | 44, 45, 46 | 74, 75 | 86 |

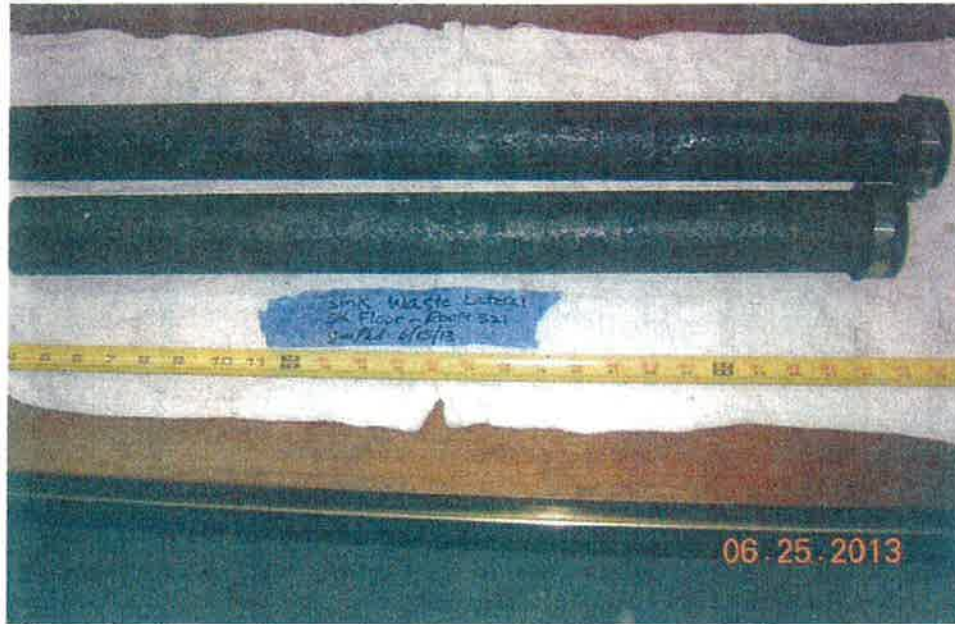
Photo 47 – Sample 16 & 17 (same section)

| TEI Sample No. | Sample Type | Location | Date Sampled | Observations | Laboratory Thickness Measurements, inch | Overall Views Photo No. | Macrographs Photo No. | Macrographs Photo No. |
|---|---|---|---|--|---|---|---|---|
| 16 | 26" long pipe, horiz. waste | 5 <sup>th</sup> floor, M-22 | 6/15/13 | Moderate/severe corrosion and build up | Intact – 0.164<br>Corroded – 0.063 | 47, 48, 49 | 76, 77 | 87 |
| 17 | 30" long pipe, horiz. waste | 5 <sup>th</sup> floor, M-22 | 6/15/13 | Moderate/severe corrosion and build up | N/A | 47 | N/A | N/A |

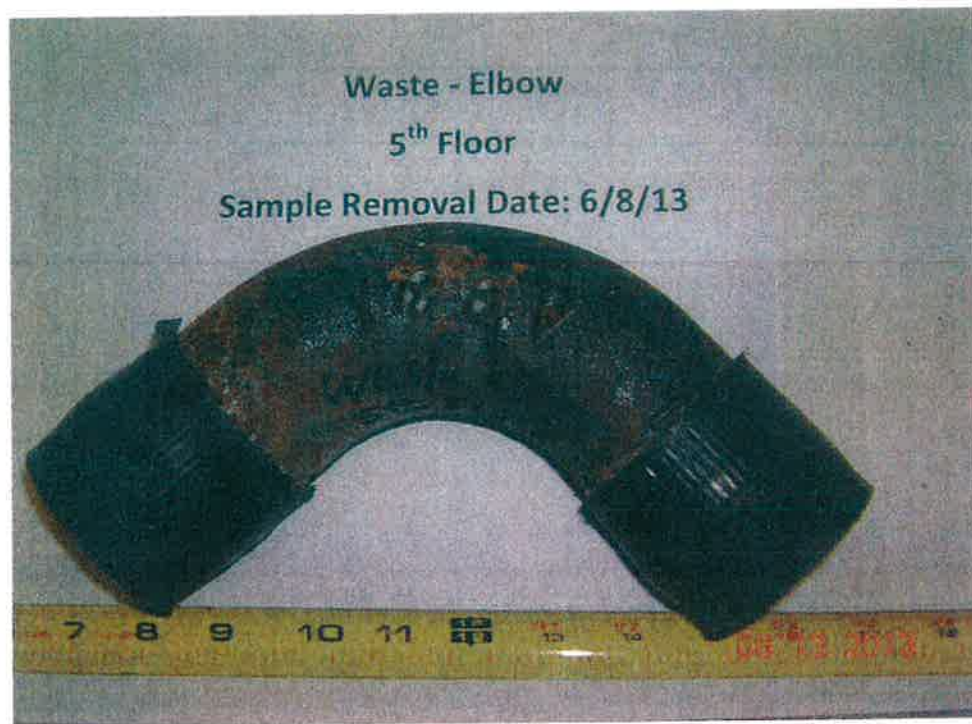
Photo 50 – Sample 18

| TEI Sample No. | Sample Type | Location | Date Sampled | Observations | Laboratory Thickness Measurements, inch | Overall Views Photo No. | Macrographs Photo No. | Macrographs Photo No. |
|---|---|---|---|--|---|---|---|---|
| 18 | Fitting, waste | 5 <sup>th</sup> floor L-18 | 6/8/13 | Minimal corrosion and build up | N/A | 50, 51, 52 | N/A | N/A |

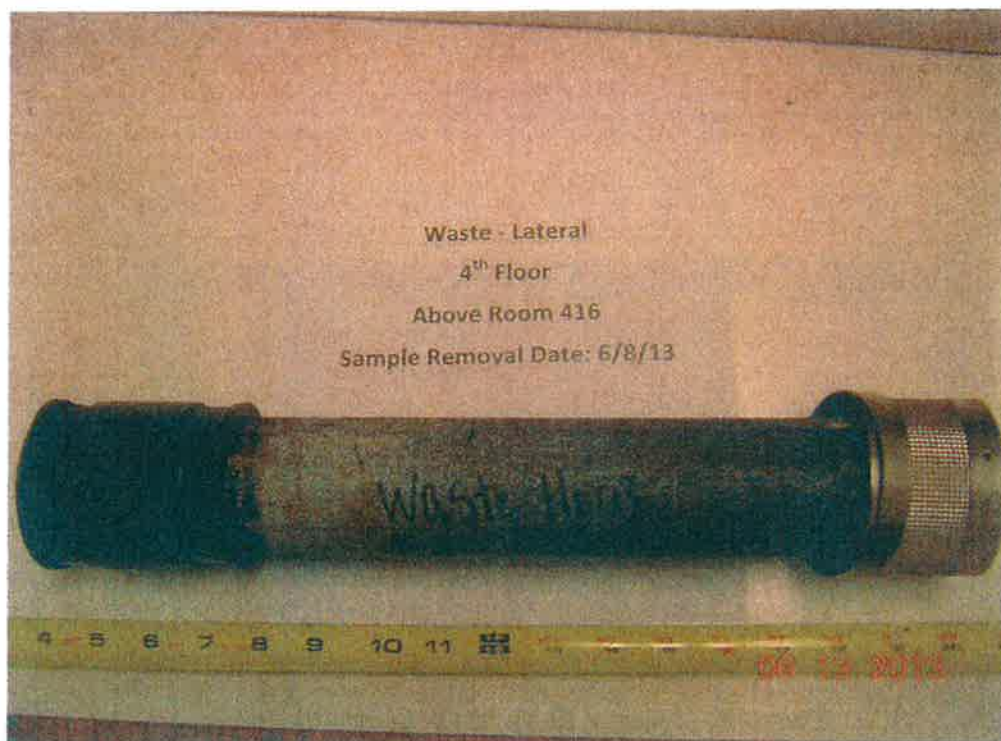
Photo 53 – Sample 19

| TEI Sample No. | Sample Type | Location | Date Sampled | Observations | Laboratory Thickness Measurements, inch | Overall Views Photo No. | Macrographs Photo No. | Macrographs Photo No. |
|---|---|---|---|--|---|---|---|---|
| 19 | 13" long pipe, horiz. waste | 4 <sup>th</sup> floor, room 416 | 6/8/13 | Severe corrosion, moderate/severe build up | N/A | 53, 54, 55 | N/A | N/A |

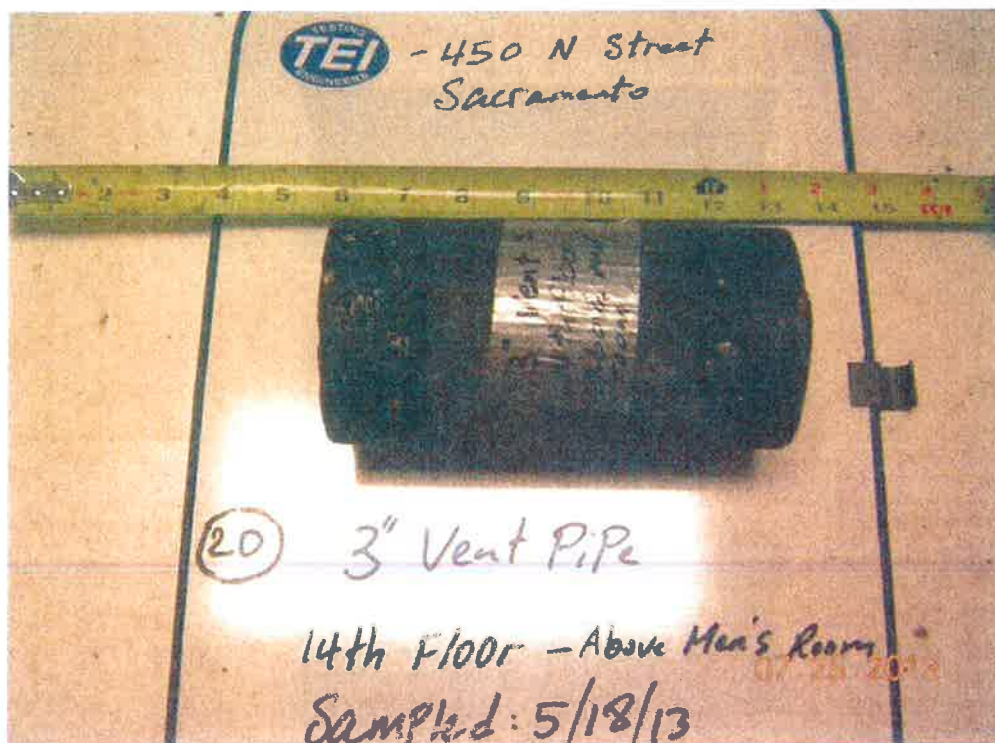
Photo 56 – Sample 20

| TEI Sample No. | Sample Type | Location | Date Sampled | Observations | Laboratory Thickness Measurements, inch | Overall Views Photo No. | Macrographs Photo No. | Macrographs Photo No. |
|---|---|---|---|--|---|---|---|---|
| 20 | 6.5" long pipe, horiz. vent | 14 <sup>th</sup> floor, men's room | 5/18/13 | No corrosion, no build up | N/A | 56, 57 | N/A | N/A |

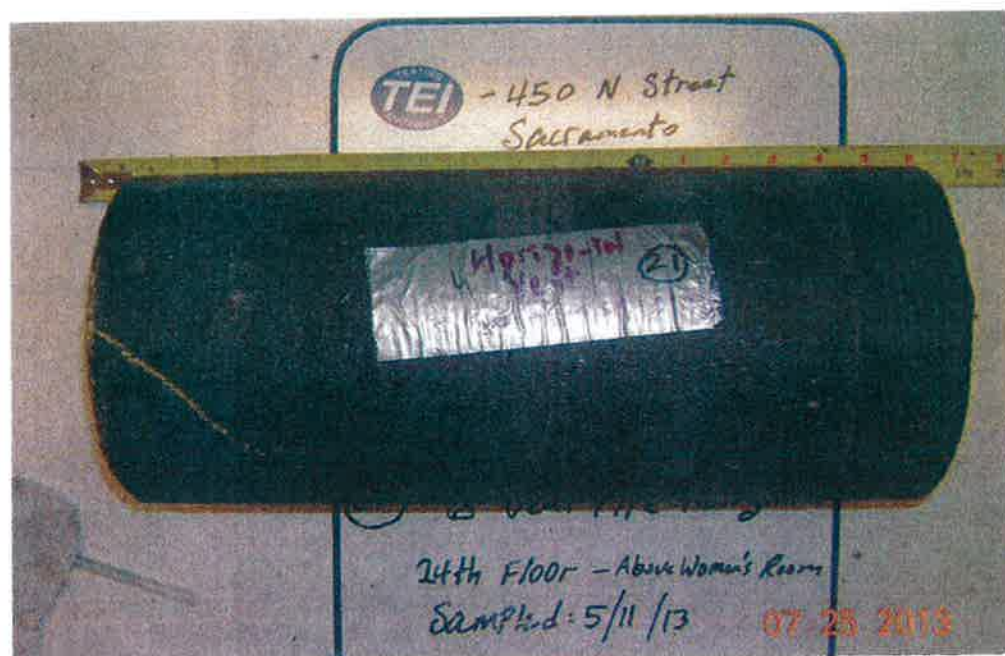
Photo 58 – Sample 21

| TEI Sample No. | Sample Type | Location | Date Sampled | Observations | Laboratory Thickness Measurements, inch | Overall Views Photo No. | Macrographs Photo No. | Macrographs Photo No. |
|---|---|---|---|--|---|---|---|---|
| 21 | 14.5" long 6" pipe, horiz. vent | <del>22<sup>nd</sup> floor</del> women's room | 5/11/13 | No corrosion, no build up | N/A | 58, 59 | N/A | N/A |

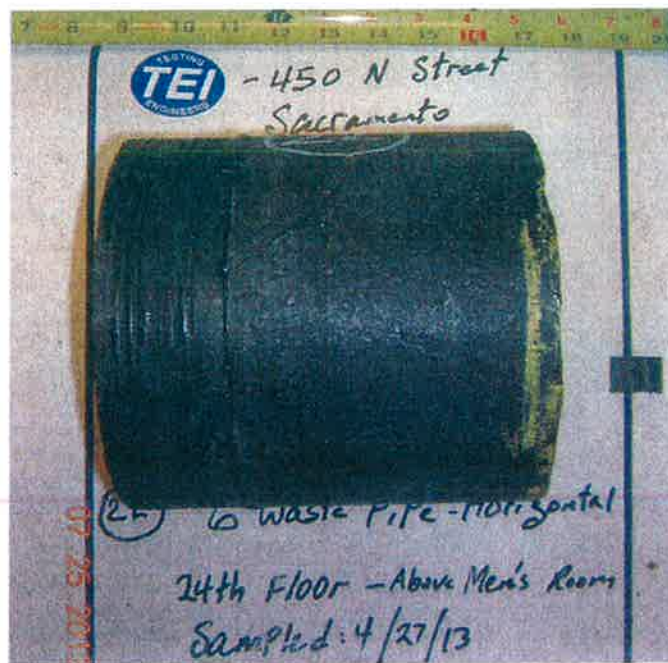
Photo 60 - Sample 22

| TEI Sample No. | Sample Type | Location | Date Sampled | Observations | Laboratory Thickness Measurements, inch | Overall Views Photo No. | Macrographs Photo No. | Macrographs Photo No. |
|---|---|---|---|--|---|---|---|---|
| 22 | 6" long 6" pipe, horiz. waste | 24 <sup>th</sup> floor, men's room | 4/27/13 | Minimal Corrosion, no build up | N/A | 60, 61 | N/A | N/A |

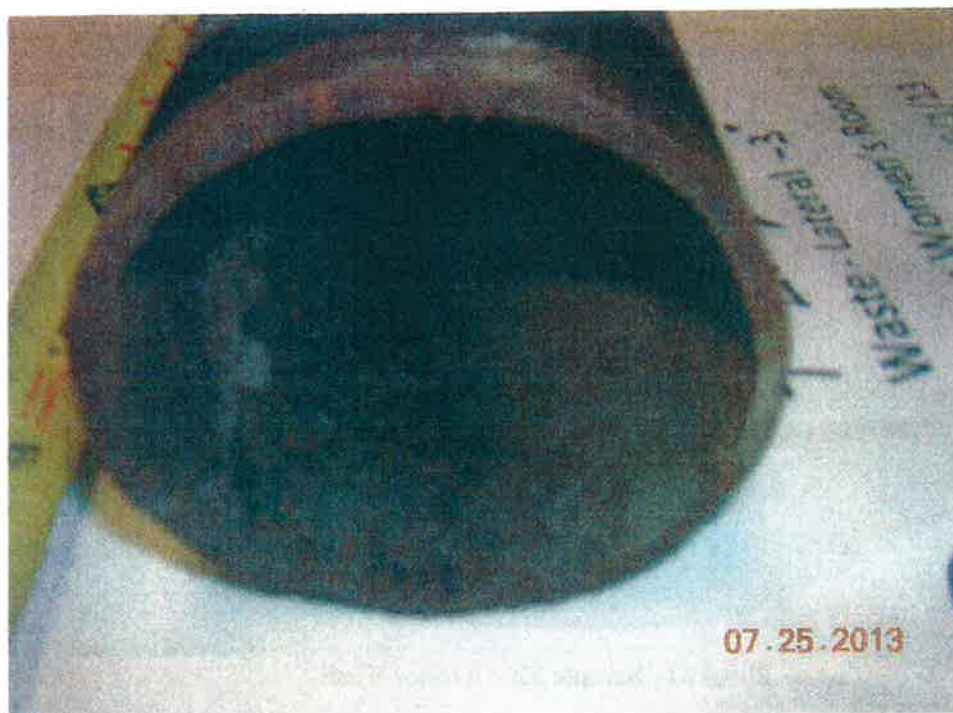
Photo 63 – Sample 23 - Interior View

| TEI Sample No. | Sample Type | Location | Date Sampled | Observations | Laboratory Thickness Measurements, inch | Overall Views Photo No. | Macrographs Photo No. | Macrographs Photo No. |
|---|---|---|---|--|---|---|---|---|
| 23 | 7" long pipe, horiz. waste | <del>3<sup>rd</sup> floor</del> women's room | 6/1/13 | No corrosion, no build up | N/A | 62, 63 | N/A | N/A |

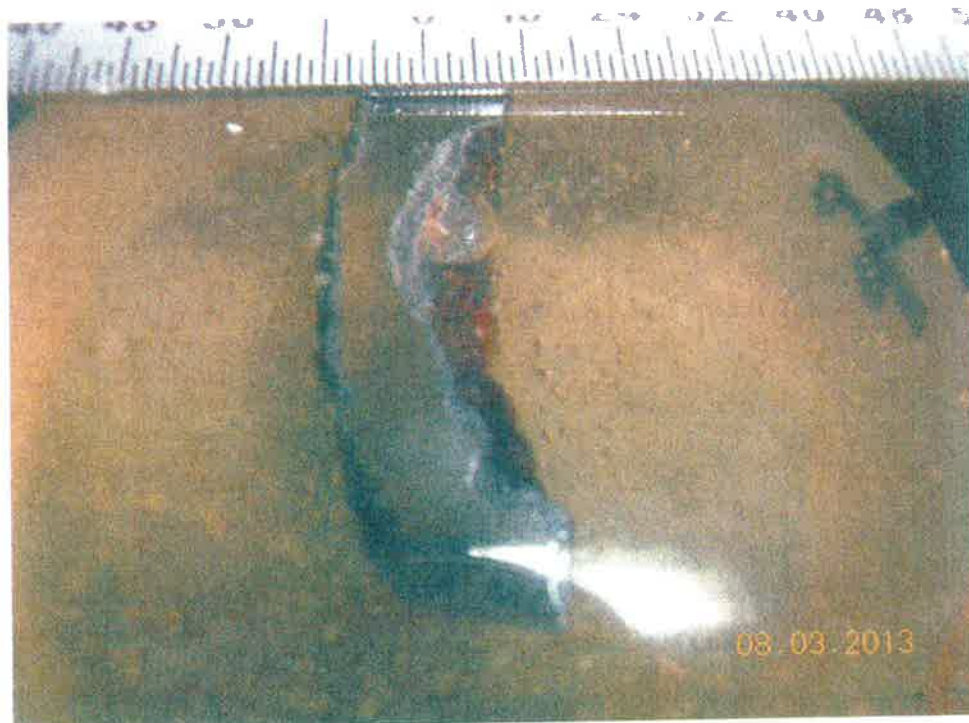
Photo 65 - Sample 4 - Cross Section

Cross sections of pipe samples that had indicated corrosion were polished and visually examined to determine the extent of corrosion. The loss in wall thickness was measured with a fine scale having 1/64" increments. The original wall thickness was also determined from an area without corrosion for reference. The results are presented in Table 2. These measurements indicated loss in pipe wall thickness of as much as 77%. The macrographs corresponding to thickness measurement data are presented in Photos 64 through 77.

| TEI Sample No. | Sample Type | Location | Date Sampled | Observations | Laboratory Thickness Measurements, inch | Overall Views Photo No. | Macrographs Photo No. | Macrographs Photo No. |
|---|---|---|---|--|--|---|---|---|
| 4 | 3" long pipe, horiz. vent | 3 <sup>rd</sup> Floor, L-19 | 7/13/13 | Minimal corrosion, severe corr. on edge, moderate build up | Intact - 0.172<br>Corroded - 0.063 (on edge) | 12, 13, 14, 15 | 65, 66 | 80 |

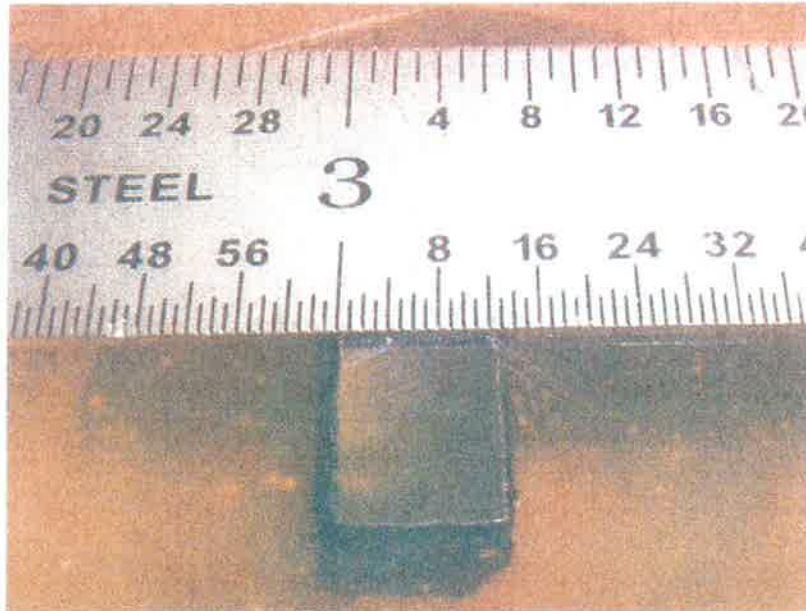
Photo 67 - Sample 5 - Cross Section

| TEI Sample No. | Sample Type | Location | Date Sampled | Observations | Laboratory Thickness Measurements, inch | Overall Views Photo No. | Macrographs Photo No. | Macrographs Photo No. |
|---|---|---|---|--|--|---|---|---|
| 5 | 22" long pipe, horiz. waste | 22 <sup>nd</sup> floor N-22 | 7/6/13 | Minimal corrosion and build up | Intact - 0.187 | 16, 17, | 67 | 81 |
